Admin Services  
Whatcom County  
Library System

Facility Assessment &  
Capital Needs Assessment  
November 2021

5 November 2021

WCLS Administrative Services Building  
Bellingham, WA

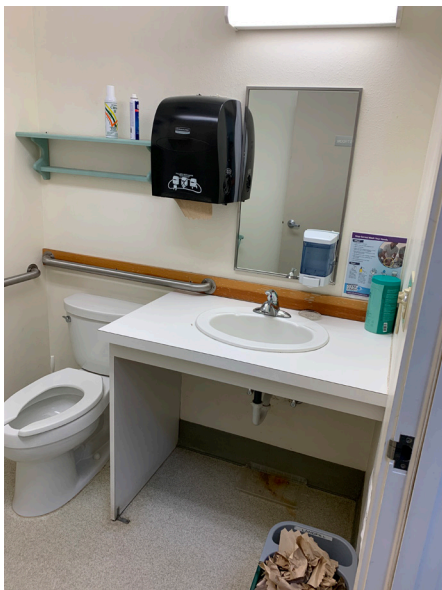
Major toilet accessory compliance issues

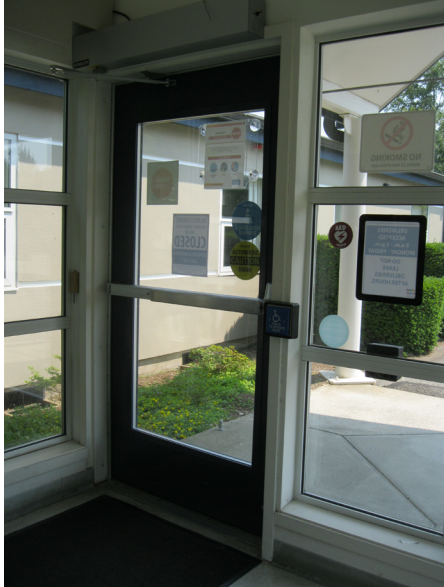
Door Condition OK-refer to ADA Matrix  
(SE toilets have a non-compliant door pull height)

Non-compliant push/pull door compliance

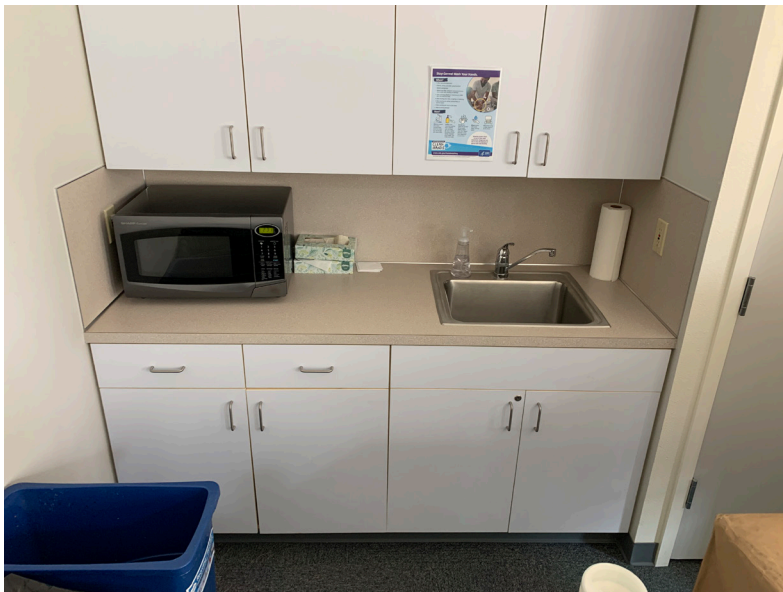
Fixture Condition: \_\_\_ Good X Fair \_\_\_ Poor \_\_\_ Unknown  
 (note: sink controls are not fully ADA compliant)

Sink/counter accessibility

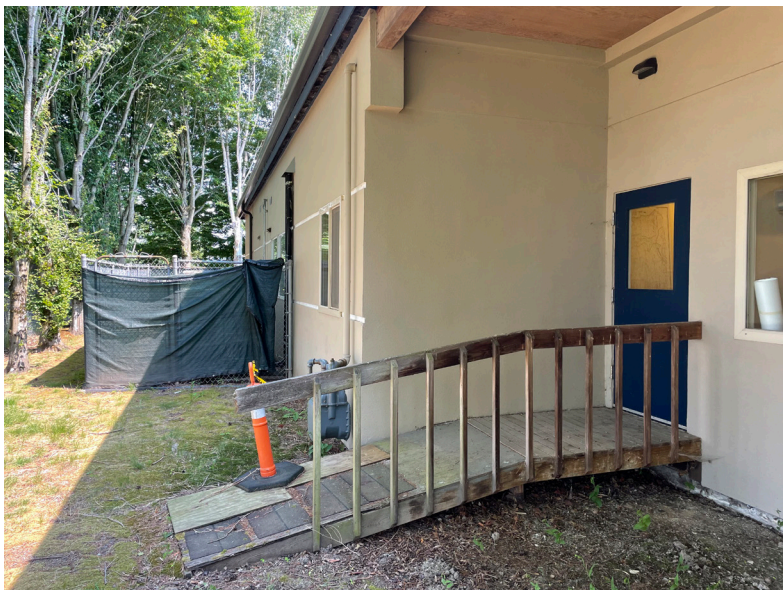
(Wood ramp at N. needs replacement - non-code compliant)  
 (No steps, only the North exit ramp)

- Wood Ramp Decay – A ramp at the north side of the building consisted of wood framing directly supported by earth. Many of the wood members on the ramp were decayed. We recommend this ramp be replaced in kind with a ramp made from treated lumber and a concrete base to mitigate the effects of wood being in direct contact with the ground.

Replace non-compliant exit landing and ramp

| Item | EUL | Age | RUL | Condition (G, F, P) | Action | Quantity | Unit | Unit Cost | Total Cost | Comments |
|---|---|---|---|---|---|---|---|---|---|---|
| Wood ramp and railing - replace | 30 | 21 | 9 | P | Replace Now | 12.0 | LF | \$525.00 | \$6,300.00 | 2x railing (timber), and assume 7' width of ramp |

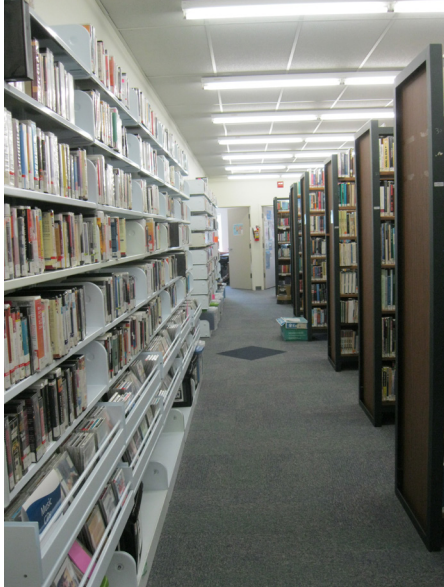
Unbraced taller than 5'-9"  
shelving

Tall and narrow library shelving can tip over during a seismic event if it is not anchored to the floor or adjacent walls. We recommend anchorage be verified and added as needed to any shelving that is taller than 6' or has a height to width ratio of 3:1 (or greater).

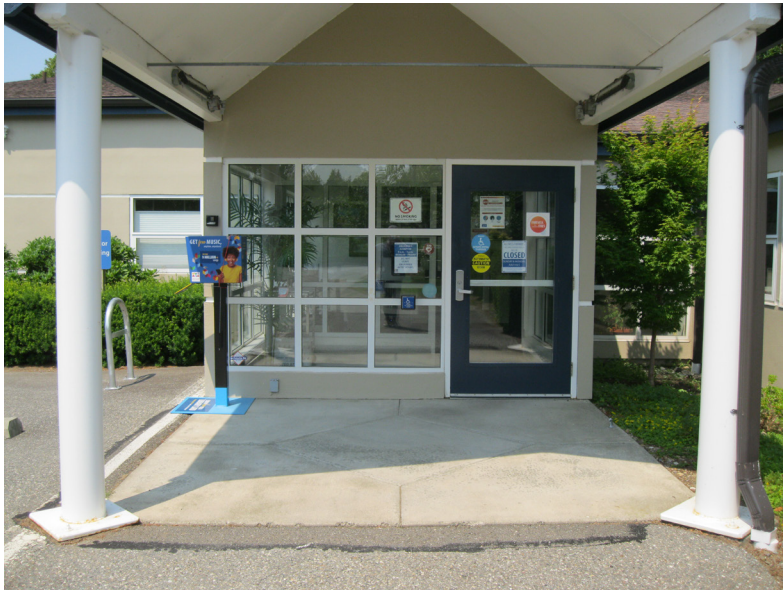
- Corrosion at Entry Canopies – Surface corrosion was visible at the baseplates of the entry canopies. We recommend the corrosion be removed and repainted to prevent future corrosion.

Steel canopy corrosion repairs

| Item | EUL | Age | RUL | Condition (G, F, P, U) | Action | Quantity | Unit | Unit Cost | Total Cost | Comments |
|---|---|---|---|---|---|---|---|---|---|--|
| Clean Corrosion/Repaint Steel Structure | 50 | 21 | 29 | P | Repair | 1 | Lump | \$2,000.00 | \$2,000.00 | |

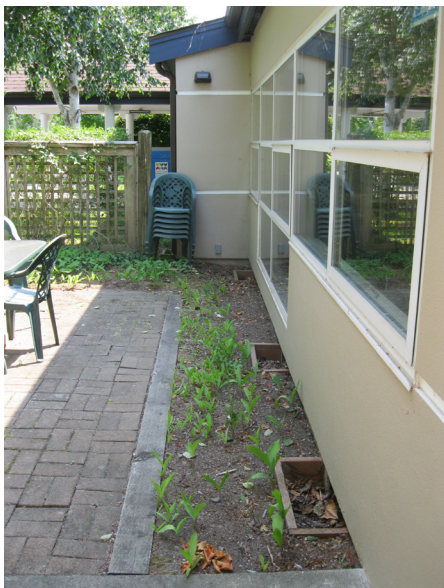
2. Admin Services has (3) foundation ventilators; installed in approx. 2005/06; installed to address "musty" foundation/crawl odors emanating into workspaces; (2) ventilators are inoperable. Crawl space does not have code-required cross ventilation and where 1990 addition covered half of original structure this was to likely address this foundation ventilation concern. RMC recommends these ventilators be repaired and linked to a timer switch to operate more consistently in the "wet" seasons. Filters should not be necessary at roof ventilators if exhaust has bird and insect screening.

3. Total Area of Building: 15,945 SF; Per 2018 IBC 1202.4.1.2 requires 1 (one) SF of ventilation for each 1,500 SF of area OR = 10.63 net free area of foundation ventilation required in a cross ventilation pattern.

Insufficient foundation  
crawl space ventilation

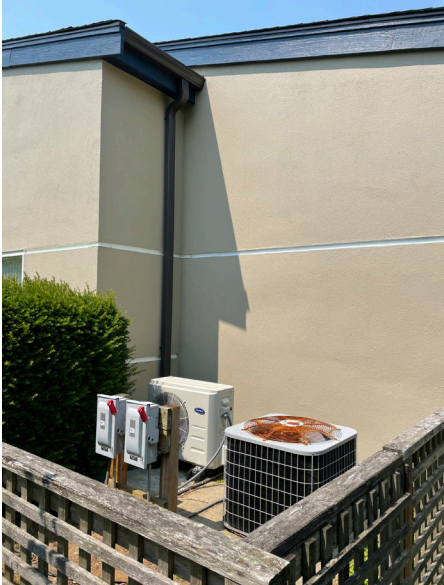
Debris management at condensing units

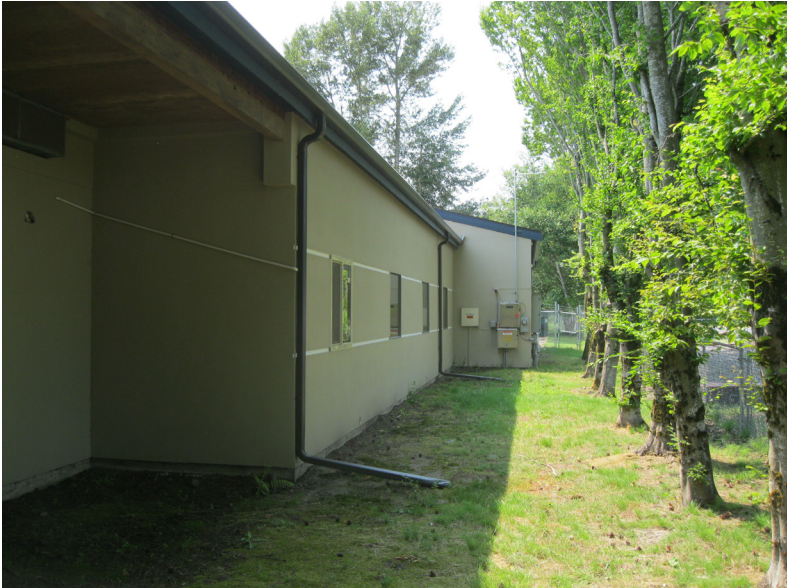
Provide extensions to north side downspouts away from building

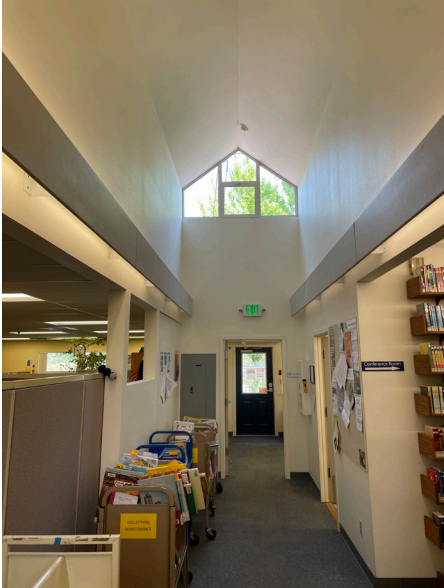
Condition: \_\_\_ Good    X Fair    \_\_\_ Poor    \_\_\_ Unknown  
 Caulk Condition    \_\_\_ Good    X Fair    \_\_\_ Poor    \_\_\_ Unknown  
 Open/Close Properly    \_\_\_ Good    X Fair    \_\_\_ Poor    \_\_\_ Unknown  
 Lock Properly    X Good    \_\_\_ Fair    \_\_\_ Poor    \_\_\_ Unknown  
 Lintel Condition    \_\_\_ Good    X Fair    \_\_\_ Poor    \_\_\_ Unknown  
 Broken Seals    (N/A) Evident at west "spine" gable units

Replace gable end windows
